Groundwater Review of Former Millbrook Jail Lands and Watershed

Final Report

By: Keyana Kamps

Completed for: Baxter Creek Watershed Alliance

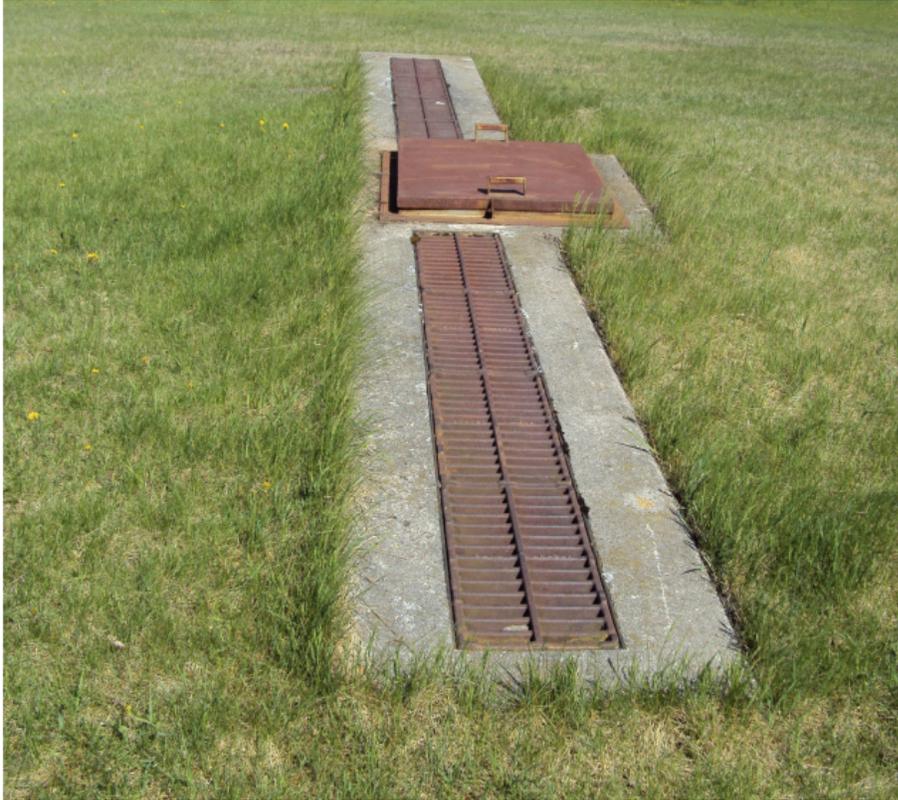
Figure 14. View of drainage trench outlet from laundry. The drain leads to the ravine at the north side of the property; distressed vegetation was observed in this area [26].

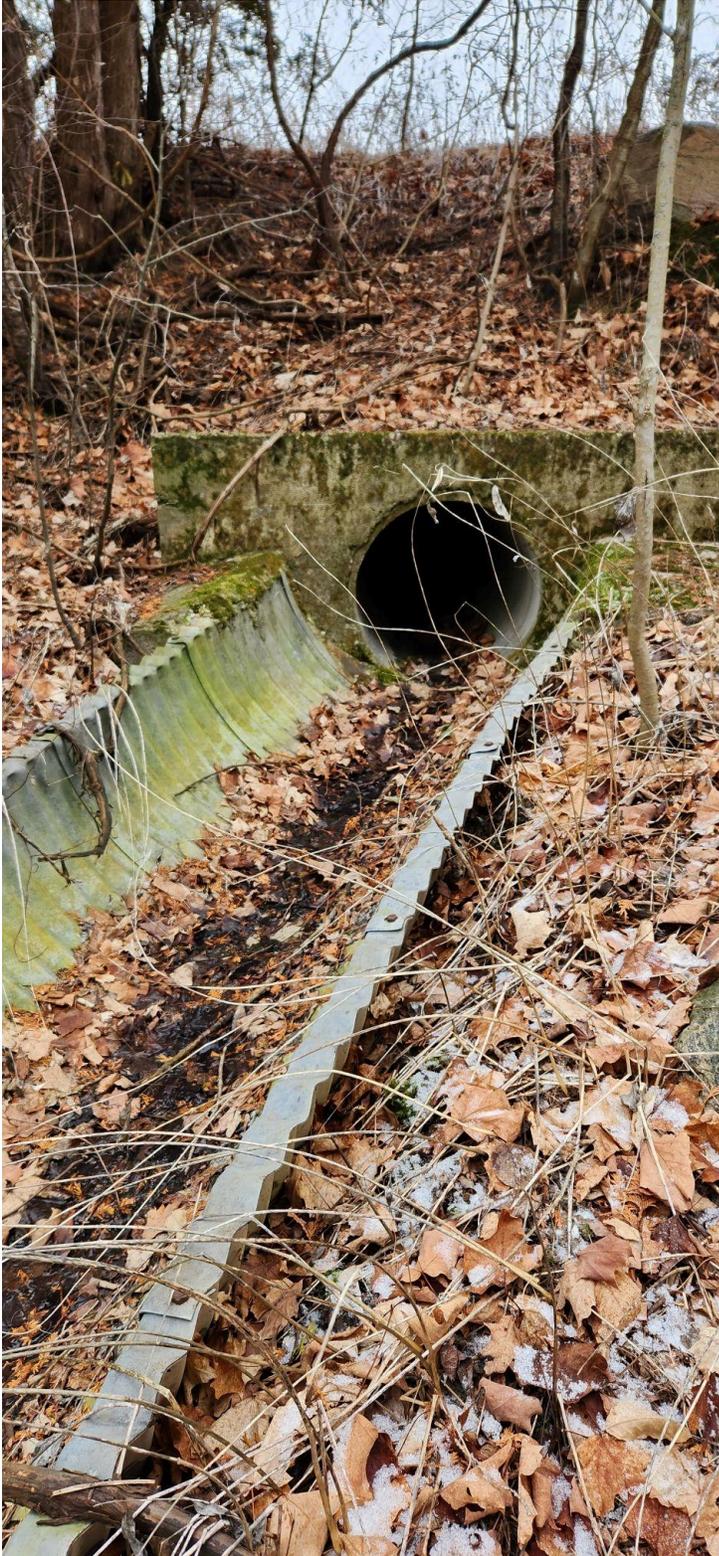
Figure 15. Half-culvert where grey water from laundry would drain to the lagoon adjacent to the onion field, near the Baxter Creek tributary; notice the steep slope of the embankment behind.

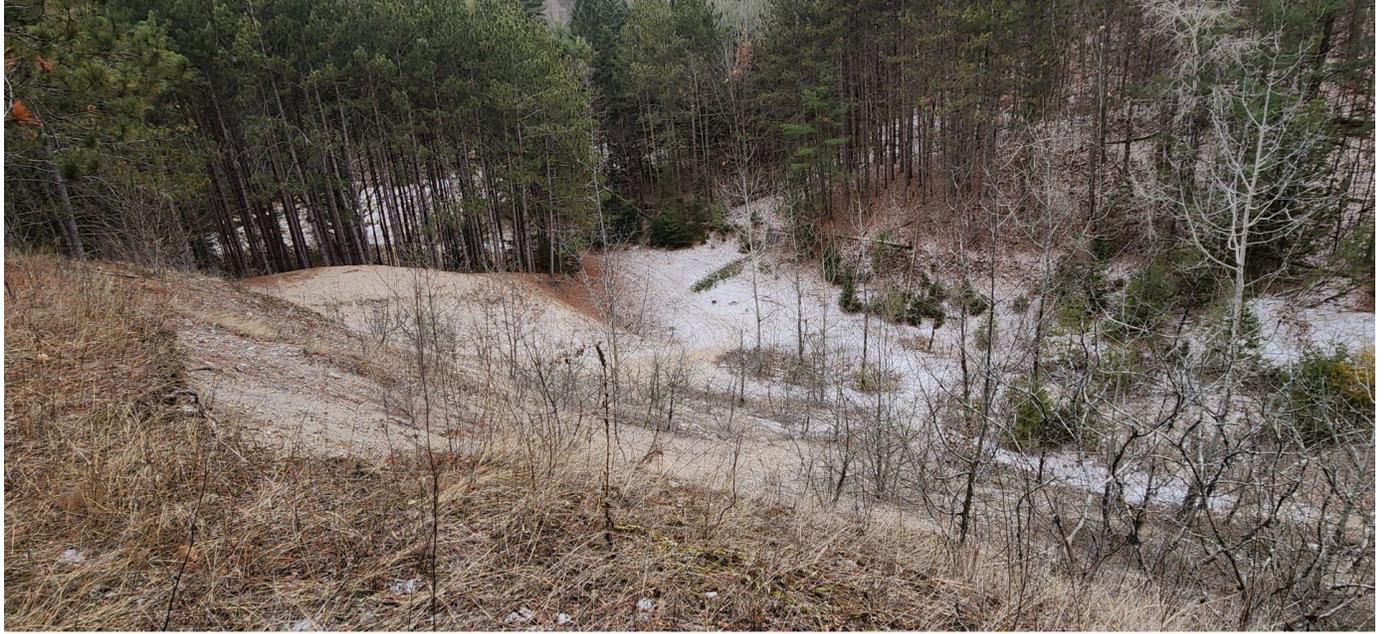
Figure 16. Sand pit. Waste was allegedly disposed of or potentially buried in this area.
