**Restoration of Brook Trout (*Salvelinus fontinalis*) Habitat in Baxter Creek**

Final Report

By: Jessica Livingstone

Completed for: Trout Unlimited Millbrook

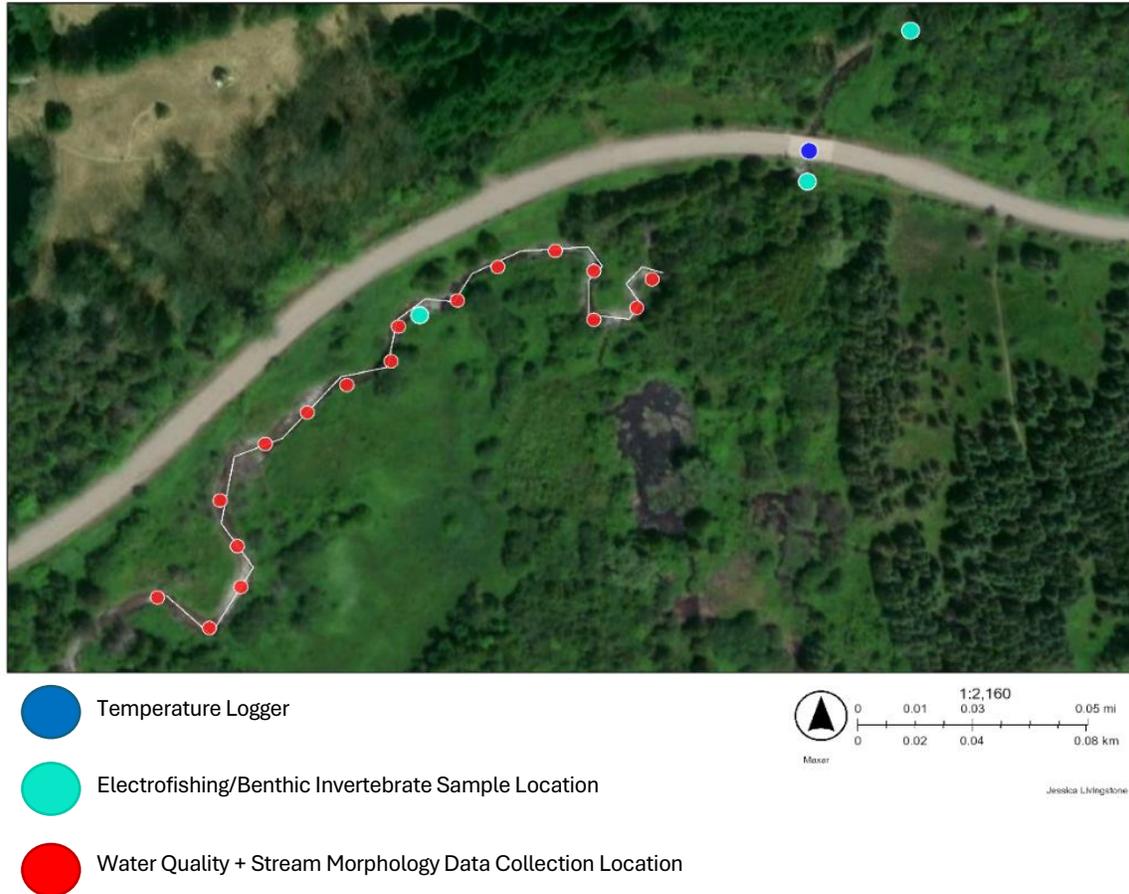
Figure 3. Map of data collection locations (temperature, electrofishing, benthic invertebrates, water quality, stream morphology) in Baxter Creek at Zion Line.

To gain a better understanding of the current conditions at this site, various field data were collected along a 350m stretch of Baxter Creek (Figure 3). Data consisting of water quality parameter and stream morphology measurements was collected along this stretch every 20m in transects across the stream cross-section (indicated with red circles in Figure 3). Alongside this, historic benthic invertebrate and electrofishing data from 2022 (light blue circles, Figure 3) and temperature data from a logger placed during the year of 2024 (dark blue circle, Figure 3) were also provided for this study by Brian Round and Jim Bowlby.

Monitoring will be key to ensure this restoration is successful. Monitoring should include vegetation surveys (outlined in *Section 3.4.3 Monitoring & Contingency (Seeding Native Species)*), electrofishing surveys, benthic invertebrate surveys, and water quality assessments. All surveys are recommended to be completed at their respective sites outlined earlier in *Figure 3*.

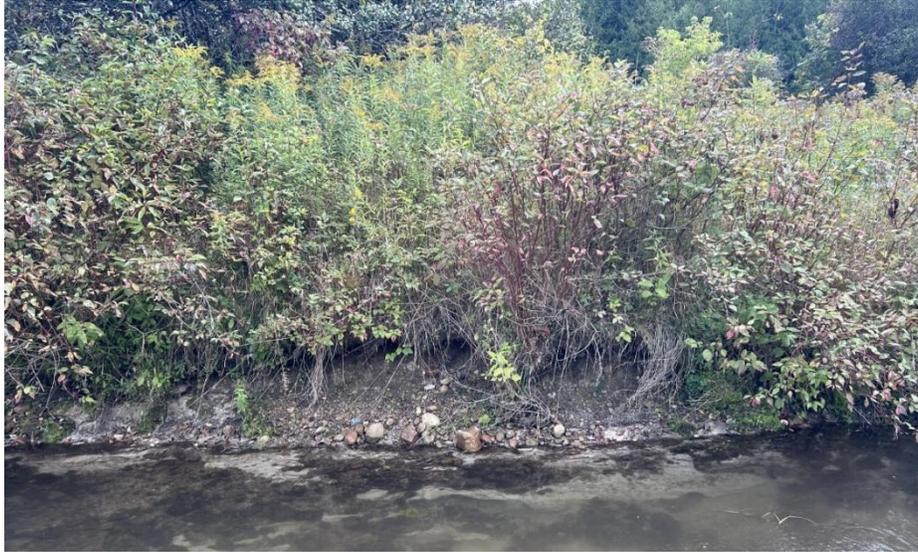
*Figure 4. An undercut bank in Baxter Creek at Zion Line.*

Currently, undercut banks at this site are cause for concern due to their instability and potential for collapse into the stream. Nevertheless, undercut banks are prime Brook Trout cover habitat. Currently, the undercuts are small and relatively unproblematic. However, they will need to be considered in the restoration plan to stabilize them and prevent them from collapsing.

Undercut banks may be eroded further and faster on the outer bends of creeks. This increases sedimentation rates, which can be detrimental to the health of benthic invertebrates (Gupta et al., 2022). Many invertebrates are extremely sensitive to changes in their environment, including changes to sediment, which may influence the benthic community, the main food source of Brook Trout. To prevent erosion, brush bundles may be constructed from branches and twigs and added to areas with undercut banks (Lanark County Stewardship Council, 2021).

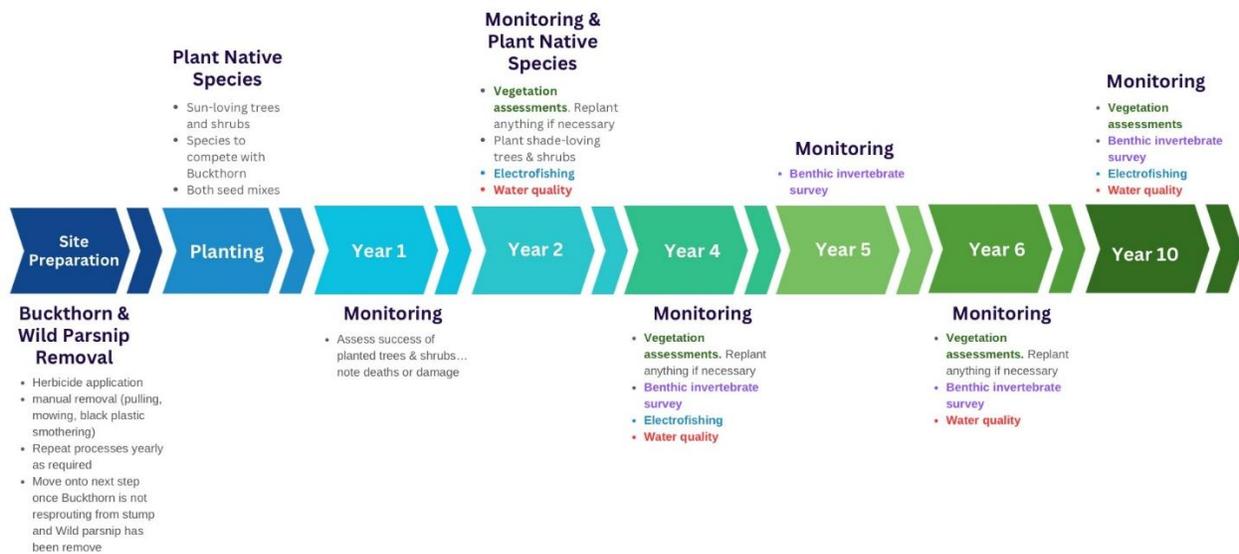
Figure 6. Restoration timeline for Baxter Creek at Zion Line. Note: Site preparation may take multiple years to complete but should be done before starting the other steps of restoration.

Restoration should be completed in the order that is presented in the report starting with buckthorn removal, then addressing vegetation diversity on-site, then bank stabilization. Placement of cover objects can occur at any point in the sequence but should be avoided in the fall (September-November) and early spring (February-April) in consideration of spawning and hatching times (Ralleigh, 1982). The time for this restoration is expected to take roughly between 10-15 years to meet all restoration goals (Figure 6).

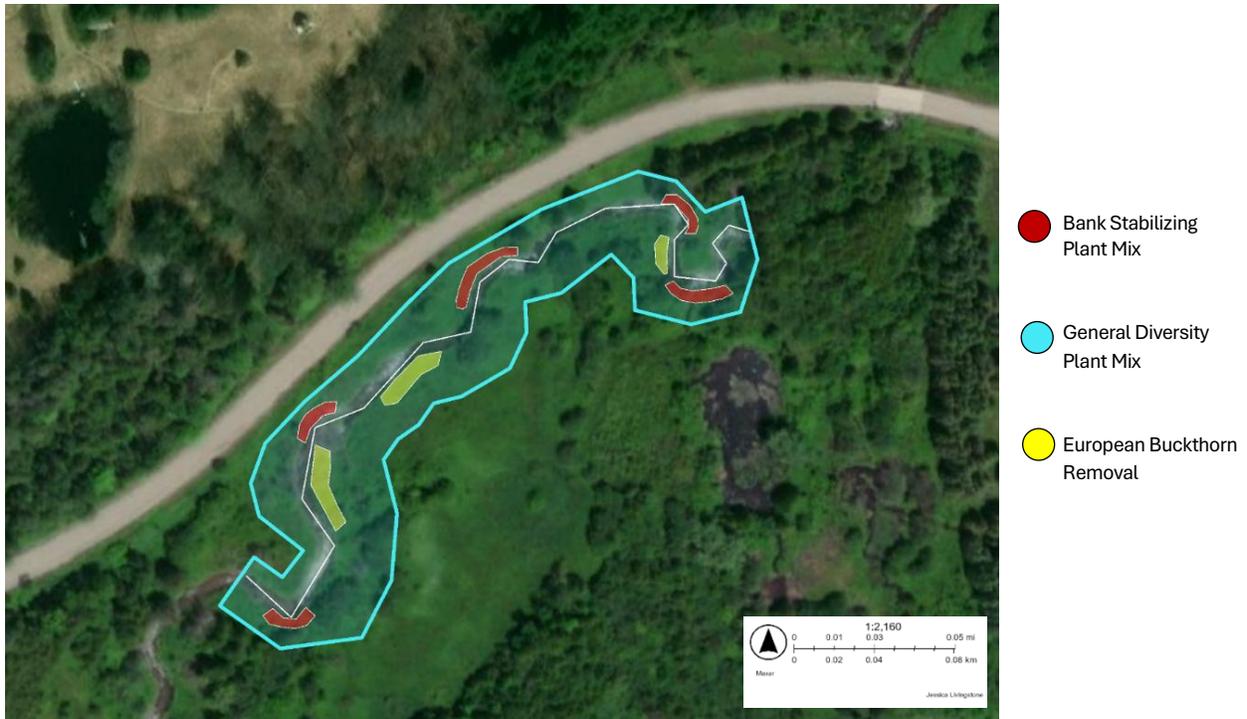
Figure 7. Proposed restoration plan for Baxter Creek at Zion Line. Blue = general diversity plant mix; Red = bank stabilization plant mix; Yellow = European Buckthorn removal.

Different aspects of the restoration plan will be implemented in specific areas along Baxter Creek (Figure 7). Buckthorn removal and replacement with native trees will occur in yellow areas. A bank stabilizing seed mix of native species will be applied in red areas, near the outer banks of the creek. A general diversity plant mix will be used in the larger blue area to increase plant diversity and add canopy cover and resilience.

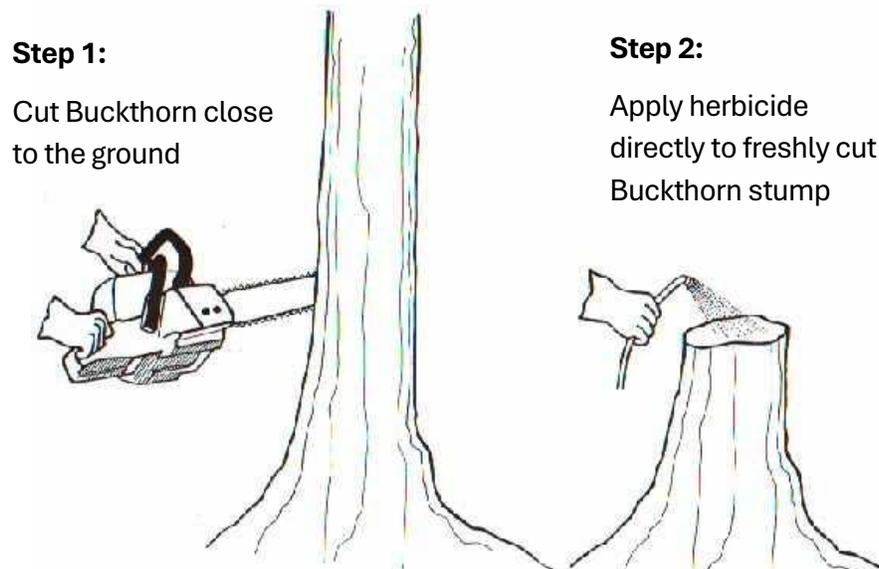
*Figure 8. How to perform the cut-stump method of herbicide application on Buckthorn.*

Buckthorn plants that are small ( $\leq 5$  cm diameter) can be removed manually via hand in April-May or October-November. This can be done by pulling out the entire plant by hand. If plants are better established, shovels may be used to loosen contact between the soil and roots to make pulling easier. Larger trees ( $> 5$  cm diameter) should be removed using the cut-stump herbicide application method between the months of May to October. A chainsaw should be used to cut the Buckthorn down to ground level (or as close to as possible). Immediately following the cut (within 30 minutes), apply herbicide. It is recommended to use Garlon™ RTU (triclopyr active agent) which can be sourced from Corteva Agriscience ([https://www.corteva.ca/en/products-and-solutions/crop-protection/garlon-rtu.html#anchor\\_3](https://www.corteva.ca/en/products-and-solutions/crop-protection/garlon-rtu.html#anchor_3)) however other herbicides may be used if the herbicide is designated for use on Buckthorn (see [here](#) for Garlon RTU label indicating Buckthorn is among the species that can be treated, pg 7). Spray herbicide directly onto the exposed stump and surrounding bark using a large paintbrush or hand-sprayer. Dye may be added to the herbicide to mark treated trees if desired (*Figure 8*). Ensure you are following directions as outlined in the Garlon RTU Herbicide Label.

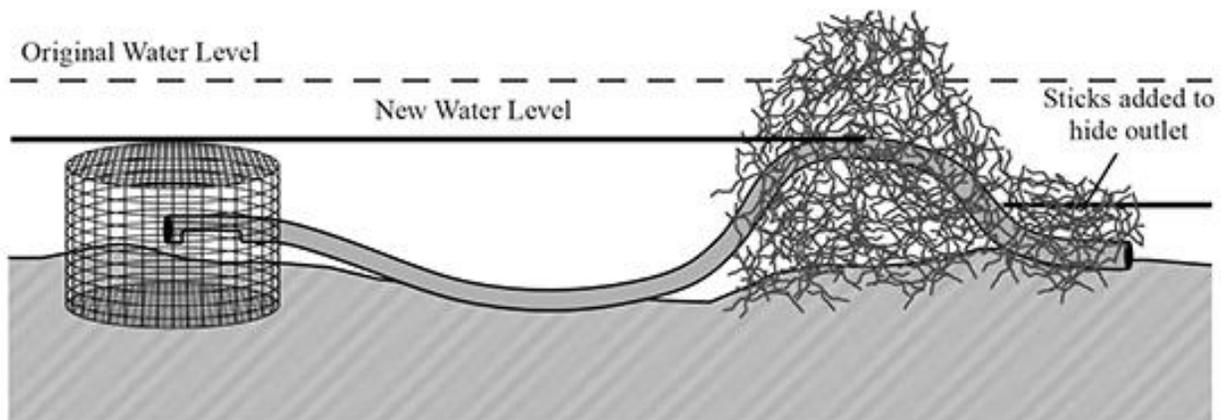
Figure 9. Beaver Deceiver diagram. (Ebbeka, 2013).

Saplings that are planted on the site can be surrounded by coconut fibre mats or other exclusion devices (e.g. fencing) to prevent damage. Chicken wire can replace these mats once the saplings are larger and sturdier (MNR, 2024b). Another consideration will be controlling water levels due to damming to prevent inundation of newly planted vegetation. Beaver deceivers are a water control device that allows beavers to continue building dams on-site, while still allowing water through via a large ADS pipe that acts as a safety valve/drain (Lee, 2016). In some cases, beavers will chew through ADS piping. In these cases, replace ADS piping with 8-10" PVC piping. For an example of a beaver deceiver, see *Figure 9*.

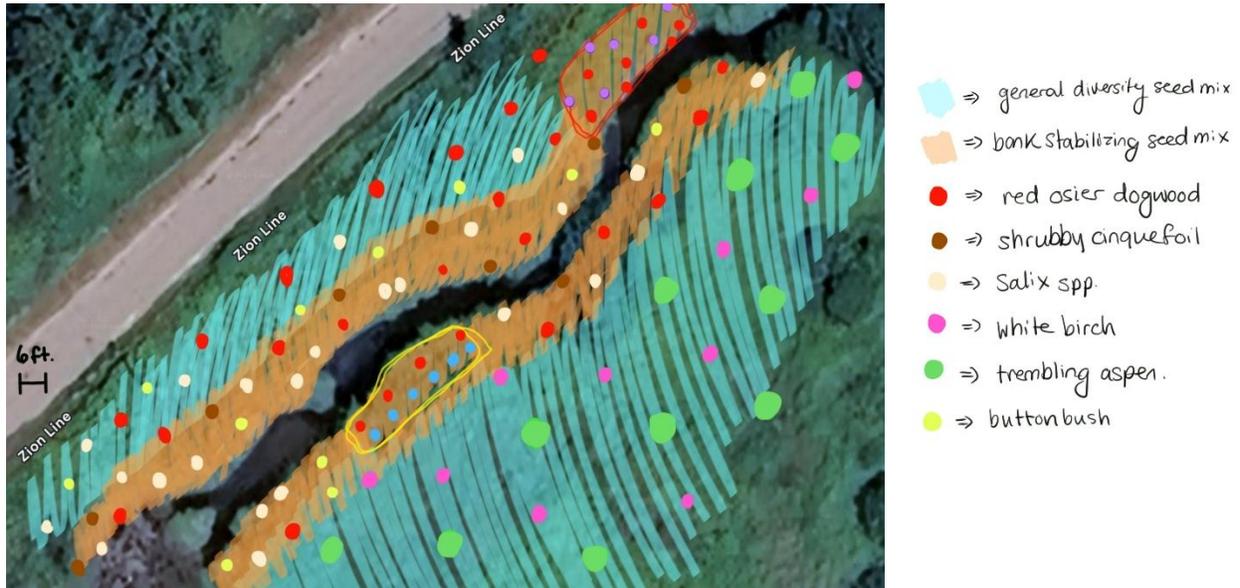
Figure 10. Replanting plan for the first year of revegetation efforts. All trees/shrubs are sun-loving species and will be the first species to be planted on the site. 6 ft is marked on the side of the left side of the map to provide context for plant spacing.

Figure 10 is an example of a replanting map that may be followed in the first year of revegetation efforts. Tree spacing and grouping will be species dependent.

In the first year of replanting native trees and shrubs, sun-loving species will be planted first. Once these species are established, shade-loving species can be planted under the new canopy. Planting patterns for shade-loving species can be done similarly to what is outlined in Figure 10.

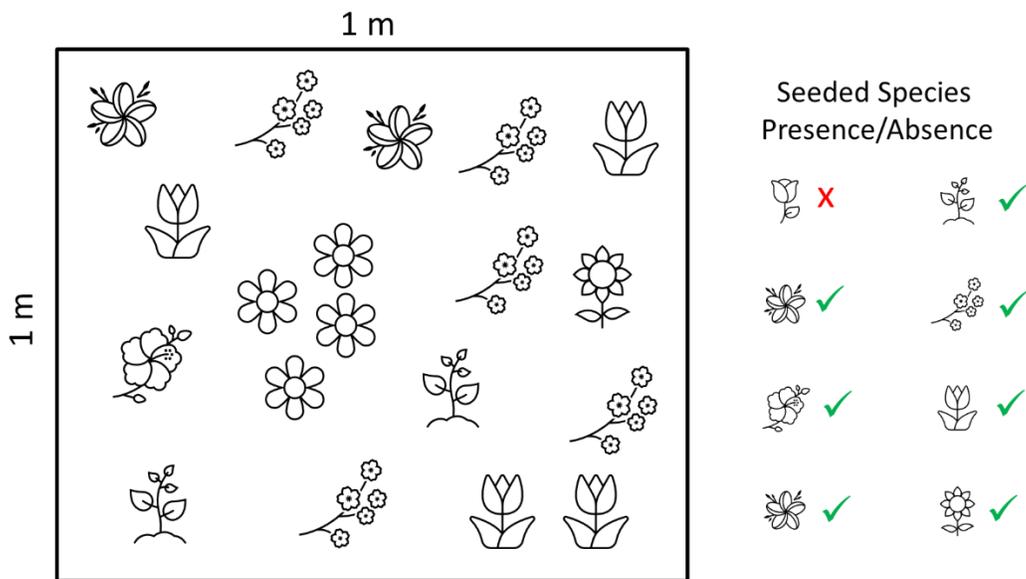
Figure 11. Determining species' presence and absence and comparing them to the list of seeded species. In this example, only one species did not establish from the seed mix. A couple of other species only have one individual established. These species could be reseeded.

To ensure the success of the revegetation efforts, presence/absence surveys should be conducted to monitor the overall effectiveness of planting efforts and assess any damage to new growth. For each seeded/planted area of approximately 100 m<sup>2</sup> (10 m by 10 m) one 1 m x 1 m quadrat can be used to assess presence/absence of herbaceous species, while a 3 m x 3 m can be used to assess shrub growth. Within each quadrat, the number and name of the species present should be recorded (Figure 11; College of Natural Resources, n.d.). The list of species present should be compared to the seeded species. Any species that did not establish could be reseeded or planted. Those that are established but do not occupy a large area could also be reseeded or planted. An estimate of total cover should also be made for each plot (Figure 12). If total cover is below the recommended values identified above, reseeding is recommended.

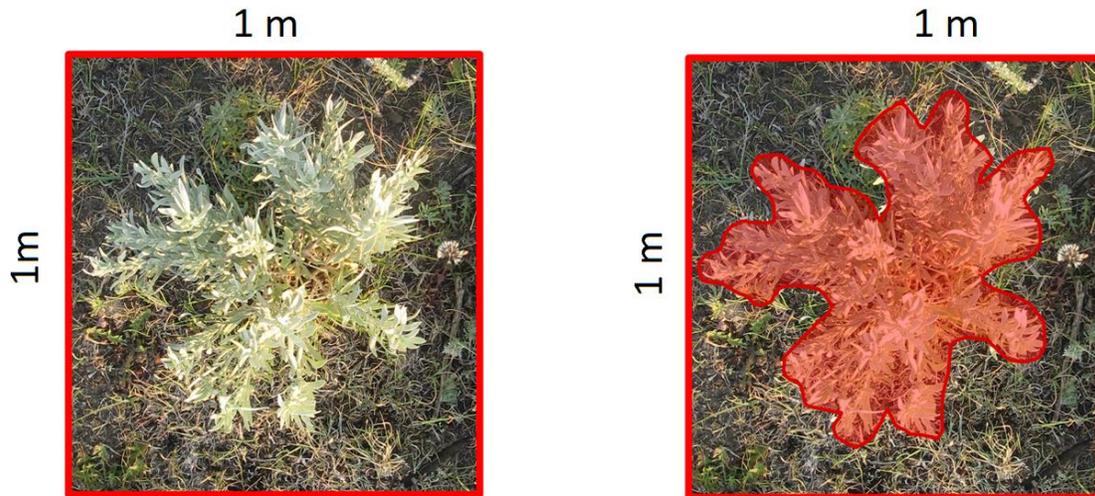
Figure 12. Visual representation of determination of percent cover. In the photo to the right, the area of the 1 m x 1 m plot, covered by the shrub, is indicated by the red area and estimated to be approximately 50%. Total cover by vegetation would be 100% as bare ground cannot be seen.

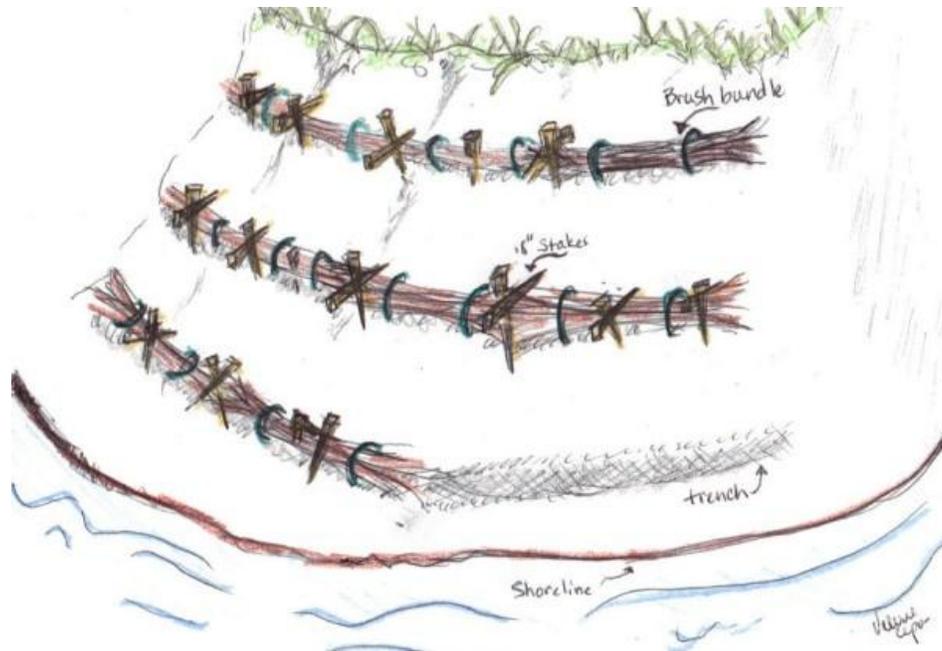
Figure 13. Brush bundles used in a stream for erosion control. Brush bundles are placed between stakes and creek bank. Twine is wrapped around both the brush bundles and the stakes to keep everything in place.

Brush bundles are made by tying together many sticks or branches together to form dense bundles. These bundles are then placed along the outer bends of the stream to prevent erosion. Brush bundles can be created following the instructions outlined by Lanark County Stewardship Council (2021) (pg. 23) found [here](#).

Brush bundles will need to be secured to the sides of the creek, which can be done using wooden stakes. Use a mallet to hit stakes into the creek bed where brush bundles will be placed. After stakes securely in the creek bed, place brush bundles between the stakes and the creek bank and tie them to the stakes using twine to secure them into place. See *Figure 13* for a diagram of how brush bundles would be placed along the creek bank.
